Waters of the United States Delineation

Leake County EDD – Site 2 - Northeast

Carthage, Leake County, Mississippi

November 13, 2023 | Terracon Project No. EB237180

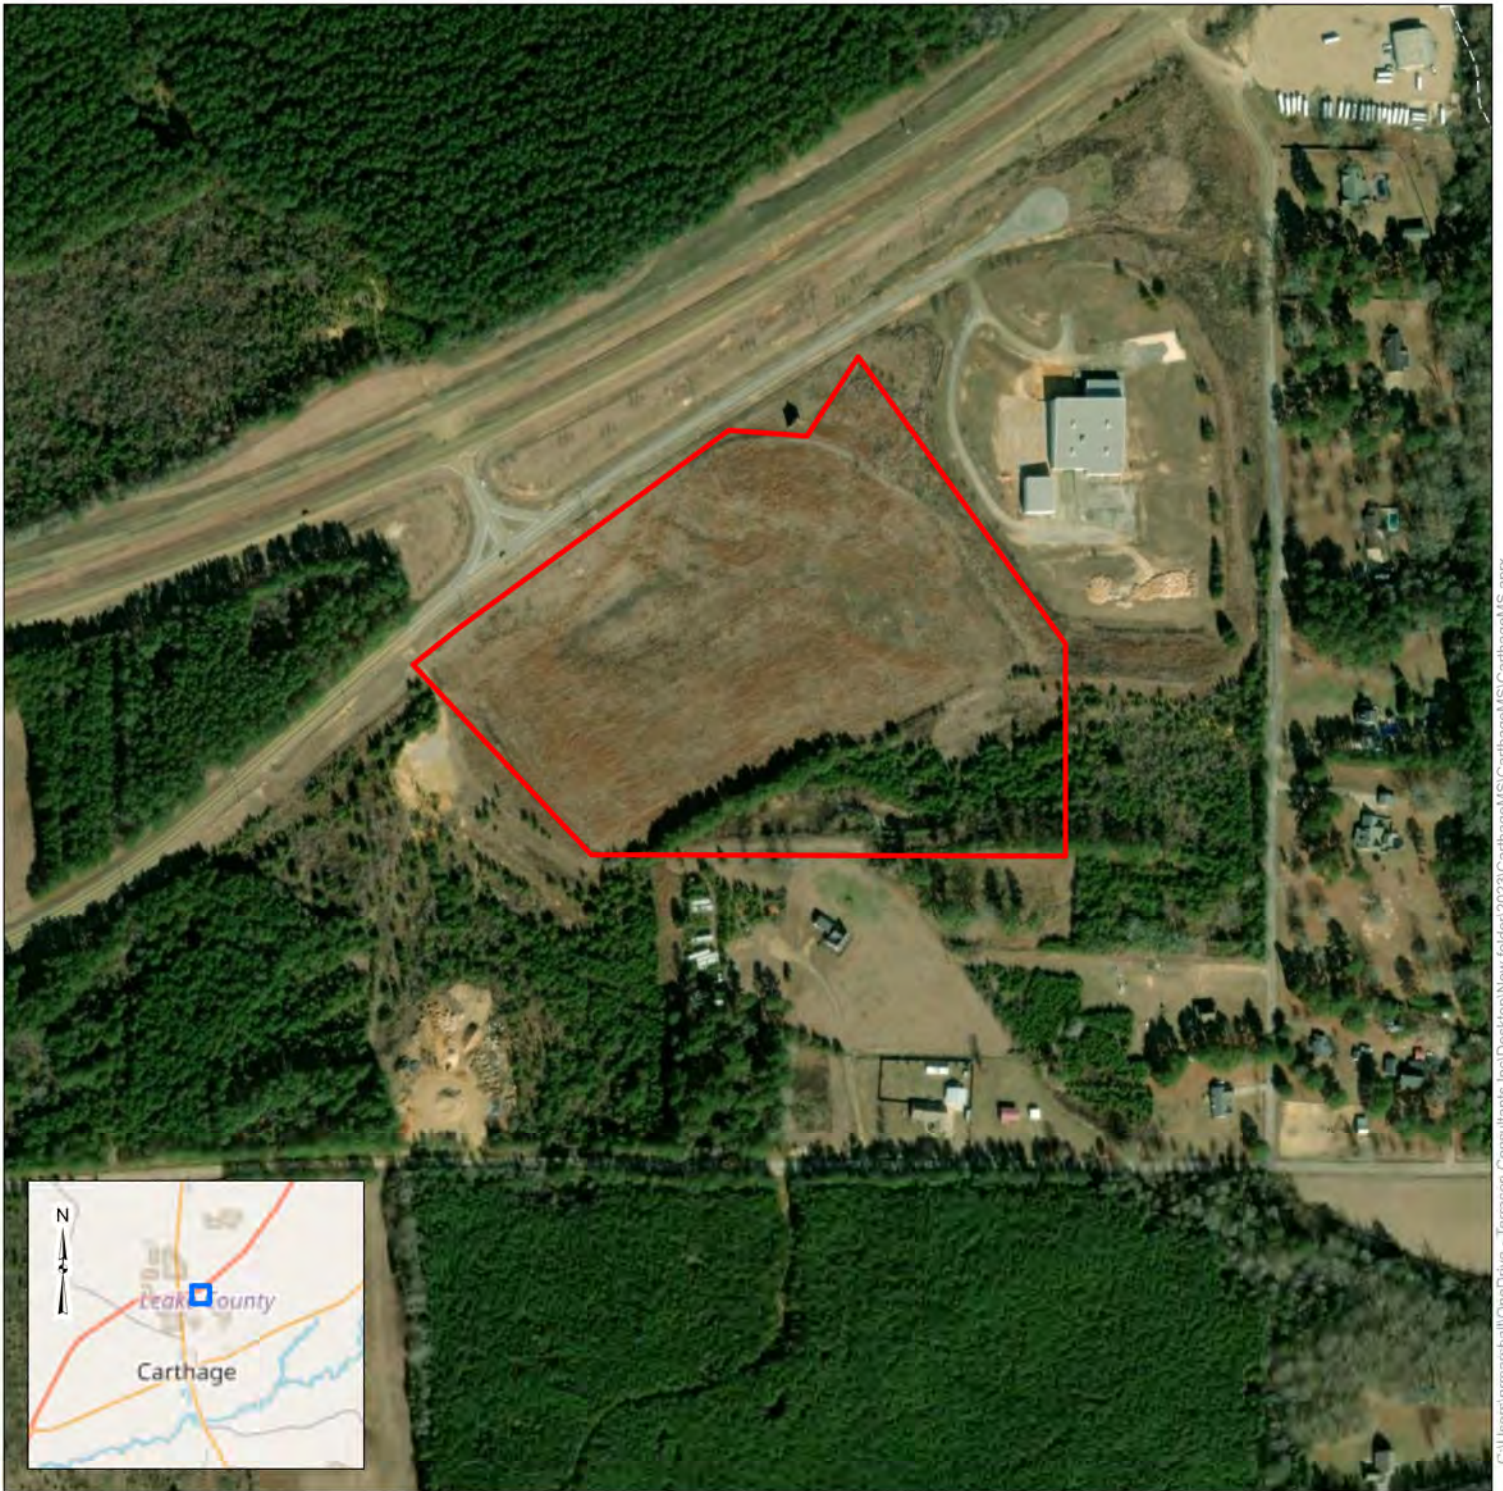
| Exhibit |
|---|
| 1.0 |

| Vicinity Map |
|---|
| MS Department of Environmental Quality Leake County EDD Site 2-NE Carthage, Leake County, MS 89°31'40"W 32°46'14"N |

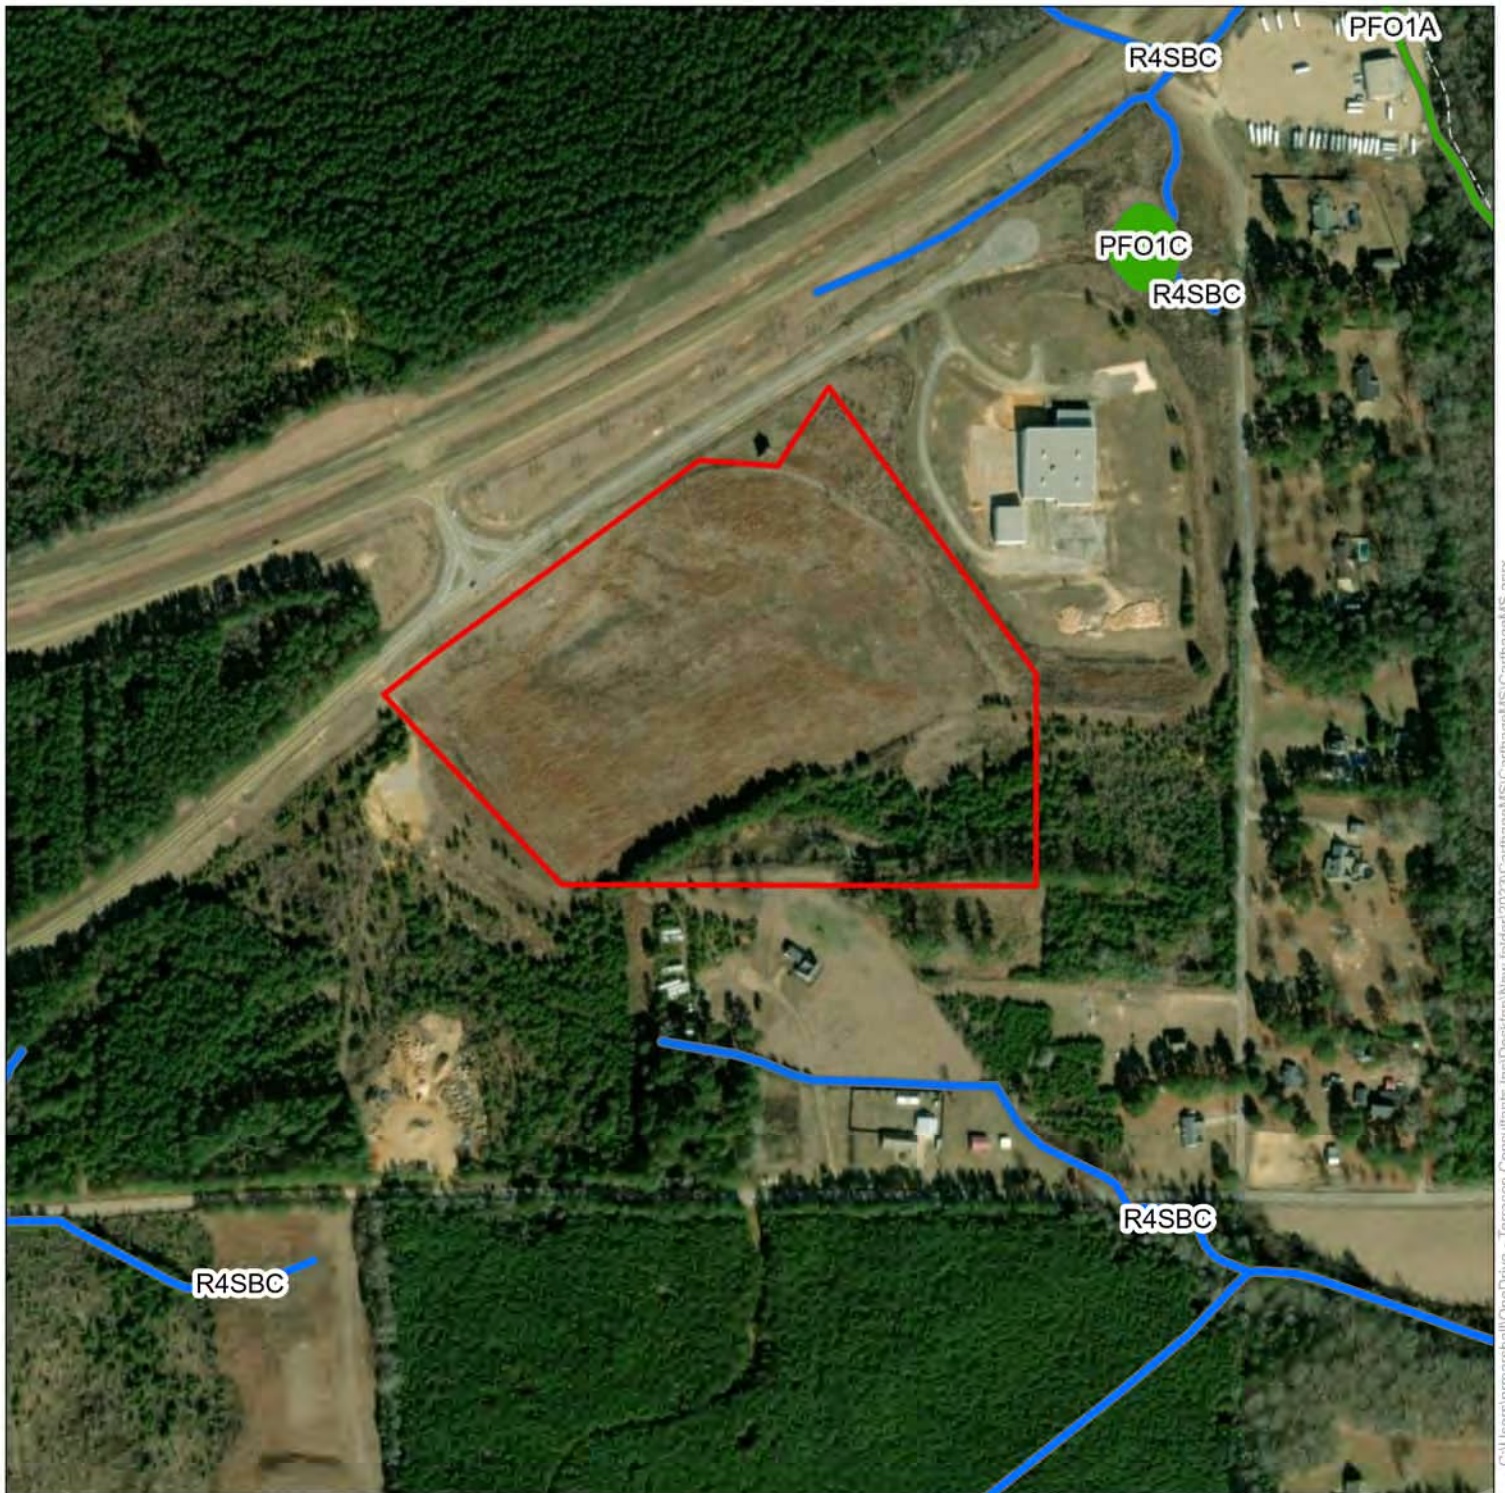
3.0

The USFWS NWI map was reviewed to identify wetland areas on the site and in the immediate vicinity. The NWI map depicts suspect wetland areas and waterbodies based on stereoscopic analysis of high-altitude aerial photographs. The NHD is used to portray surface water. The NHD represents the drainage network with features such as rivers, streams, canals, lakes, ponds, coastline, dams, and stream gages. An NWI/NHD map is included as Exhibit 3 in Appendix A.

The review of the NWI map indicates no wetlands present on-site.

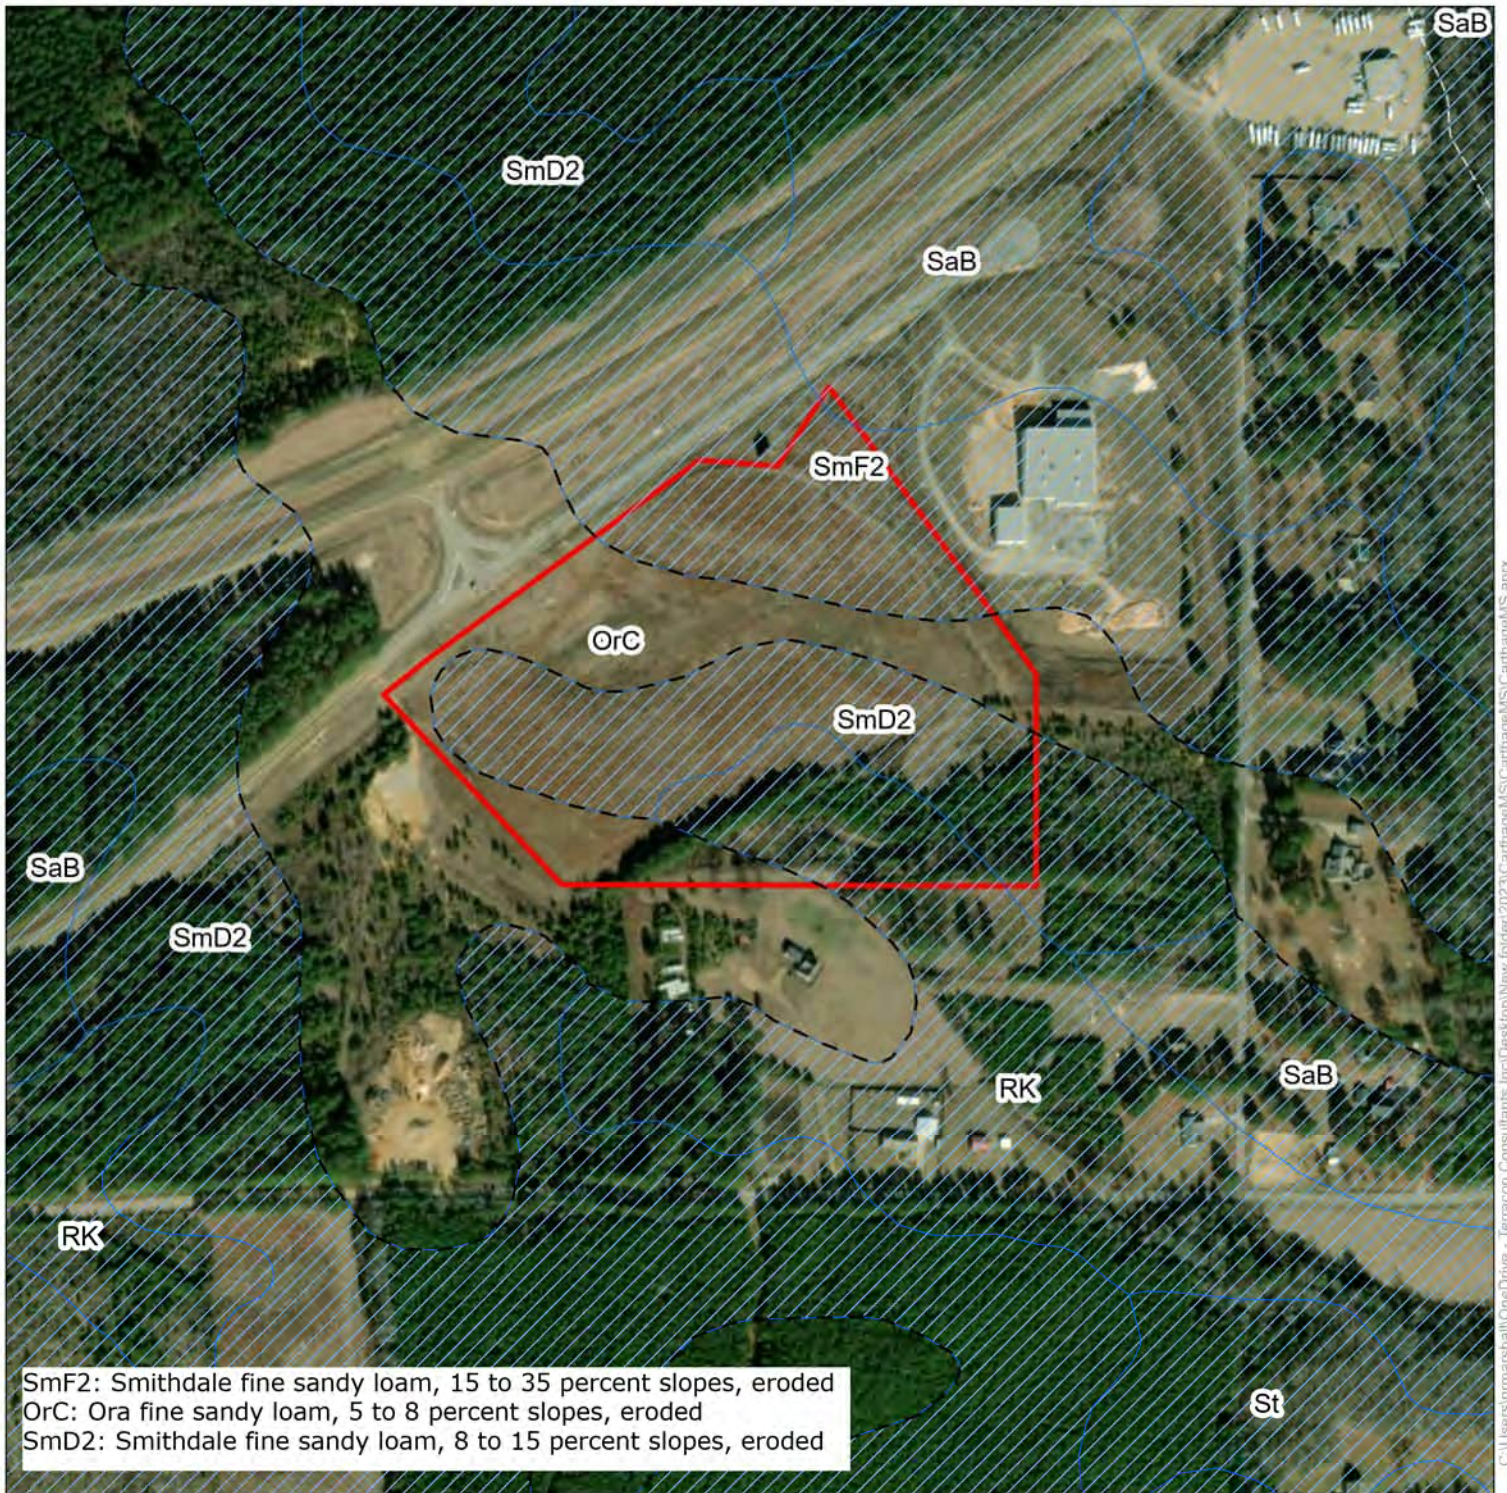
4.0

Based on a review of the NRCS soil data, a large portion of the site is made up of non-hydric soils except for an area on the southern portion of the site (Rk), see Appendix A Exhibit 4. The Rosebloom and Arkabutla soils (Rk) contains 100% hydric soils, and these soils make up approximately 13.9% of the site. These soils are in the southern portion of the site and are listed as frequently flooded.

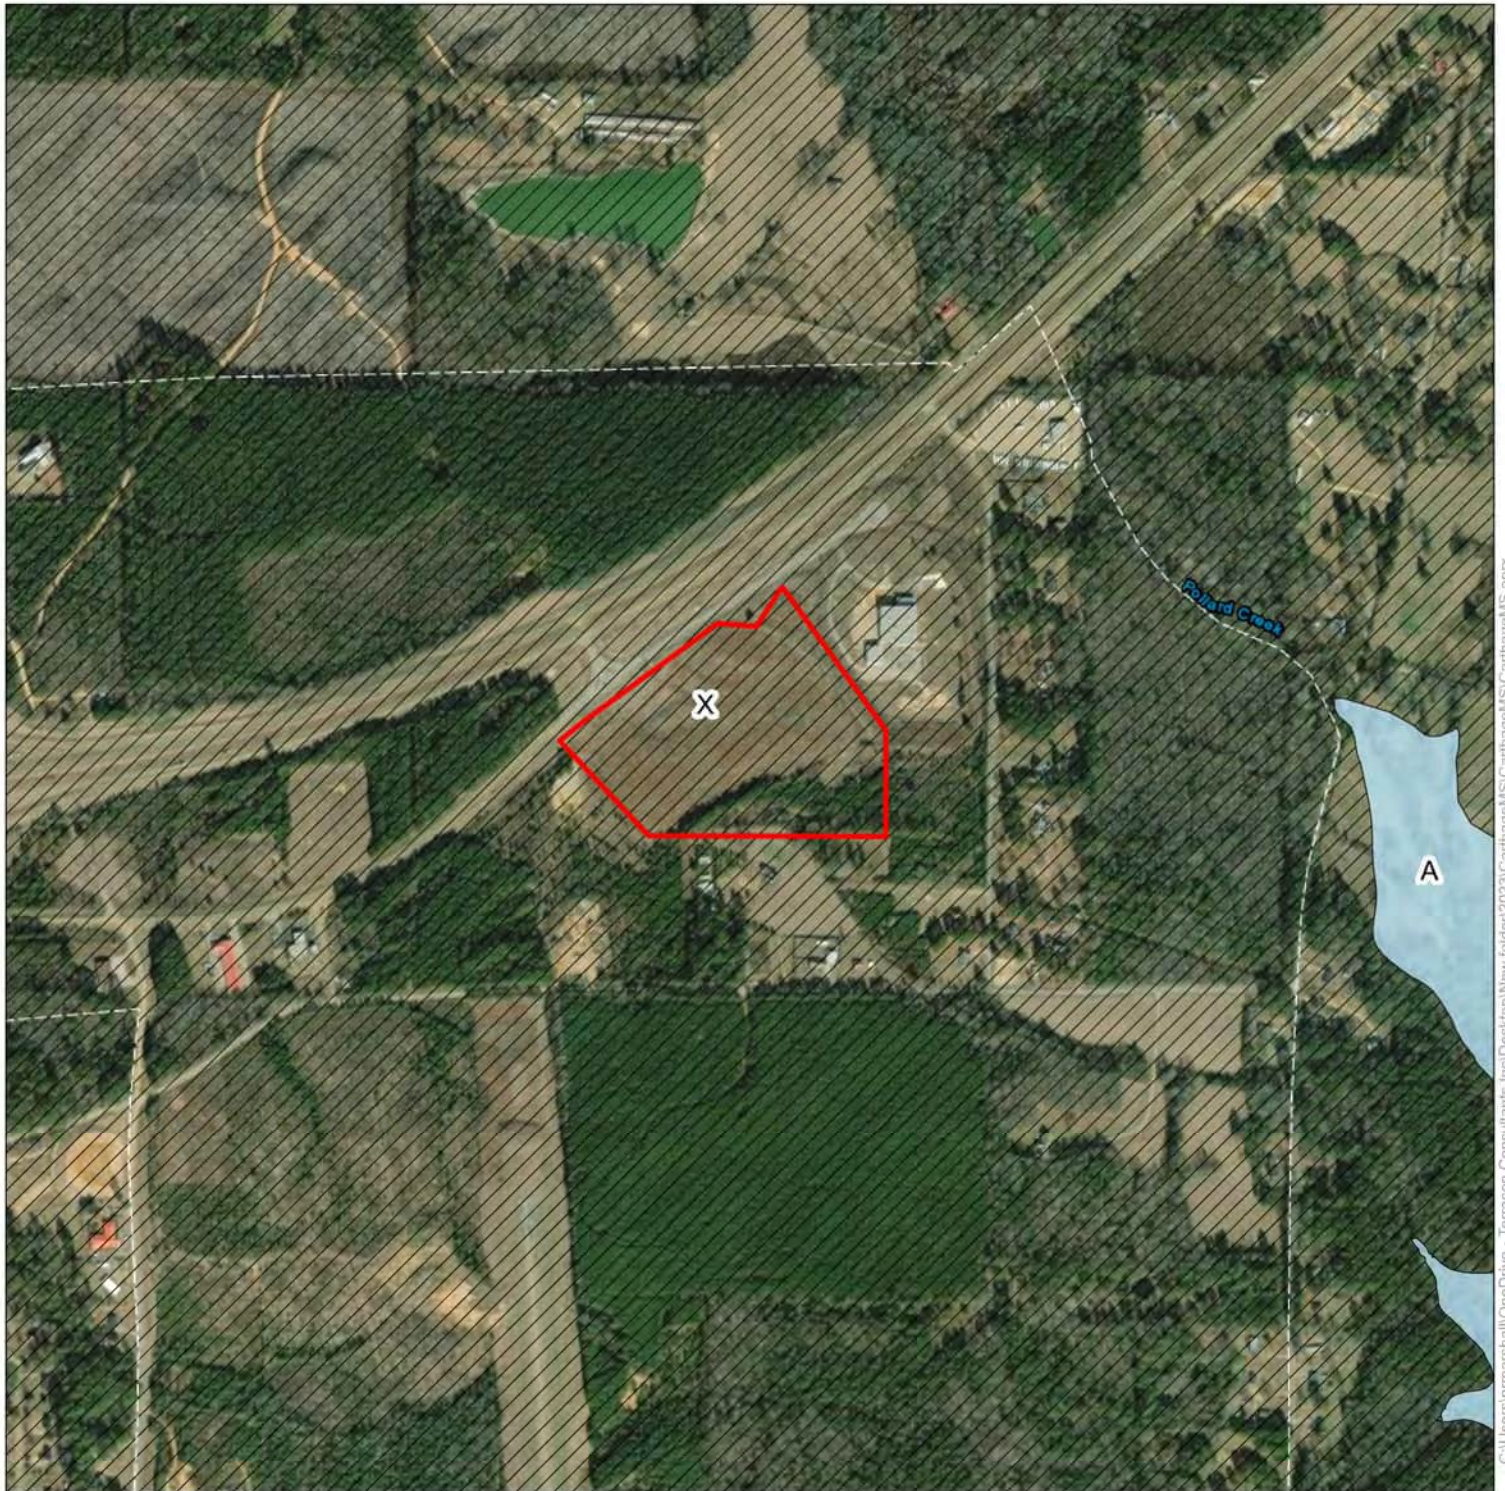
5.0

Terracon downloaded and reviewed Federal Emergency Management Agency (FEMA) Flood Insurance Rate Map (FIRM) Panel Number 28079C0143C (effective 9/16/2011). The site is in the Zone X area of the panel indicating the site is

susceptible to minimal flood risk. The FEMA map is included as Exhibit 5 in Appendix A.

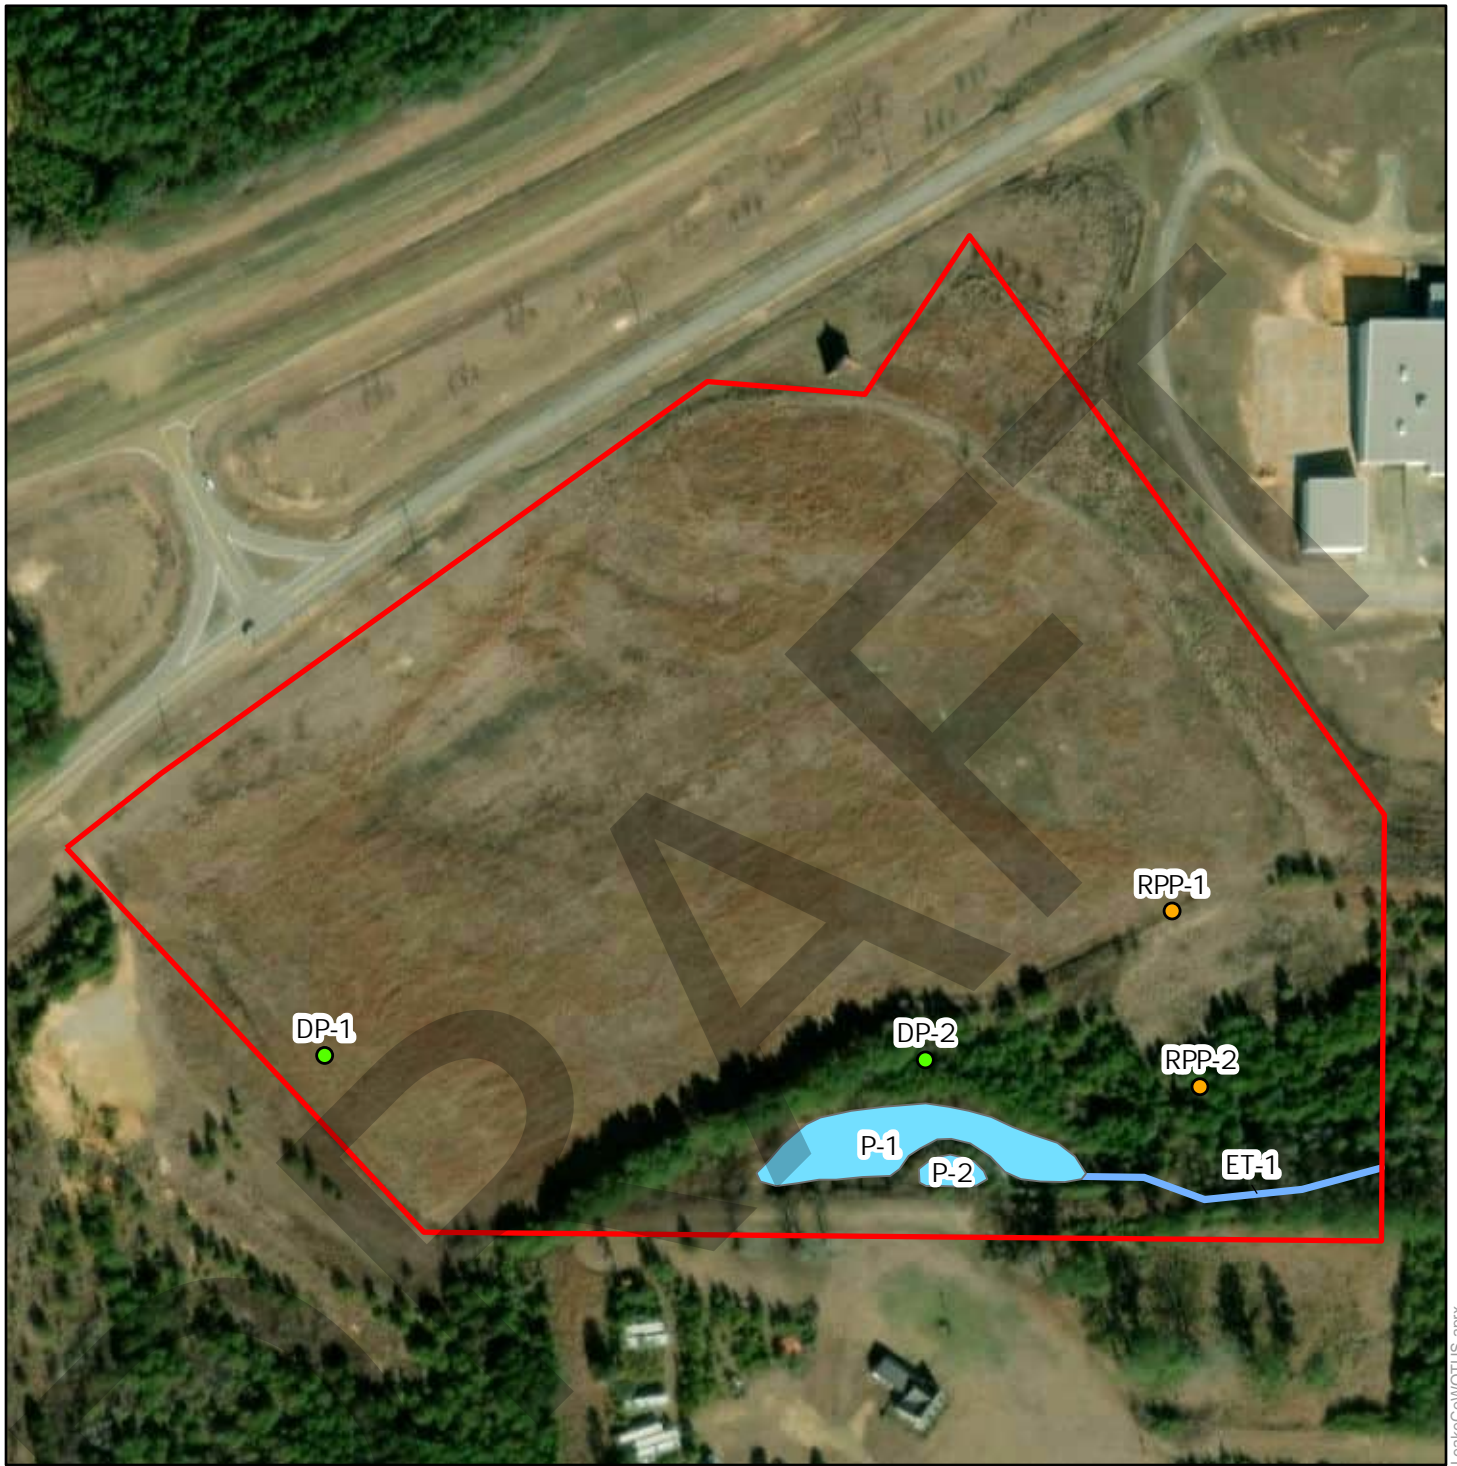
In October 2023, Terracon performed a Field Delineation on the site using the field techniques described in Section 4.0. The findings of the Field Delineation are illustrated on the Depiction of Aquatic Resources Map (Appendix A, Exhibit 7). The GIS data created using the GPS data was evaluated to determine the approximate size of each aquatic resource. Site photographs, included in Appendix C, provide an indication of the physical characteristics observed during the Field Delineation. Wetland and upland data determination forms for selected wetlands and upland locations representative of aquatic conditions on the site are provided in Appendix

Terracon observed no potentially jurisdictional tributaries on the site. One ephemeral channel totaling approximately 320 Linear Feet (LF) was identified on the site. This channel was observed on the southern portion of the site. No tributaries were observed in the northern portion of the site. This ephemeral channel was observed to be approximately 4 feet wide and approximately one foot deep or less and were found to have a non-continuous ordinary high-water mark, therefore making these channels not an intermittent stream. Photo reference points were taken in these locations to document current site conditions (see Appendix C) and a map marking the locations these photos were taken are included in Appendix A, Exhibit 7. Table 3 contains a summary of the tributaries identified on site during the Field Delineation.

Terracon observed two small ponds totaling approximately 0.42 acres near the southern boundary of the site. Because of the recent lack of rain, the ponds were not holding water, but it was obvious that they typically do hold water. The ponds had no vegetation in them at the time of this study. Because the pond features are only fed by the ephemeral tributary, they are likely not jurisdictional. Table 4 contains a summary of other aquatic features observed on the site during Field Delineation.
