Waters of the United States Delineation

Leake County EDD – Site 2 - Northeast

Carthage, Leake County, Mississippi

November 13, 2023 | Terracon Project No. EB237180

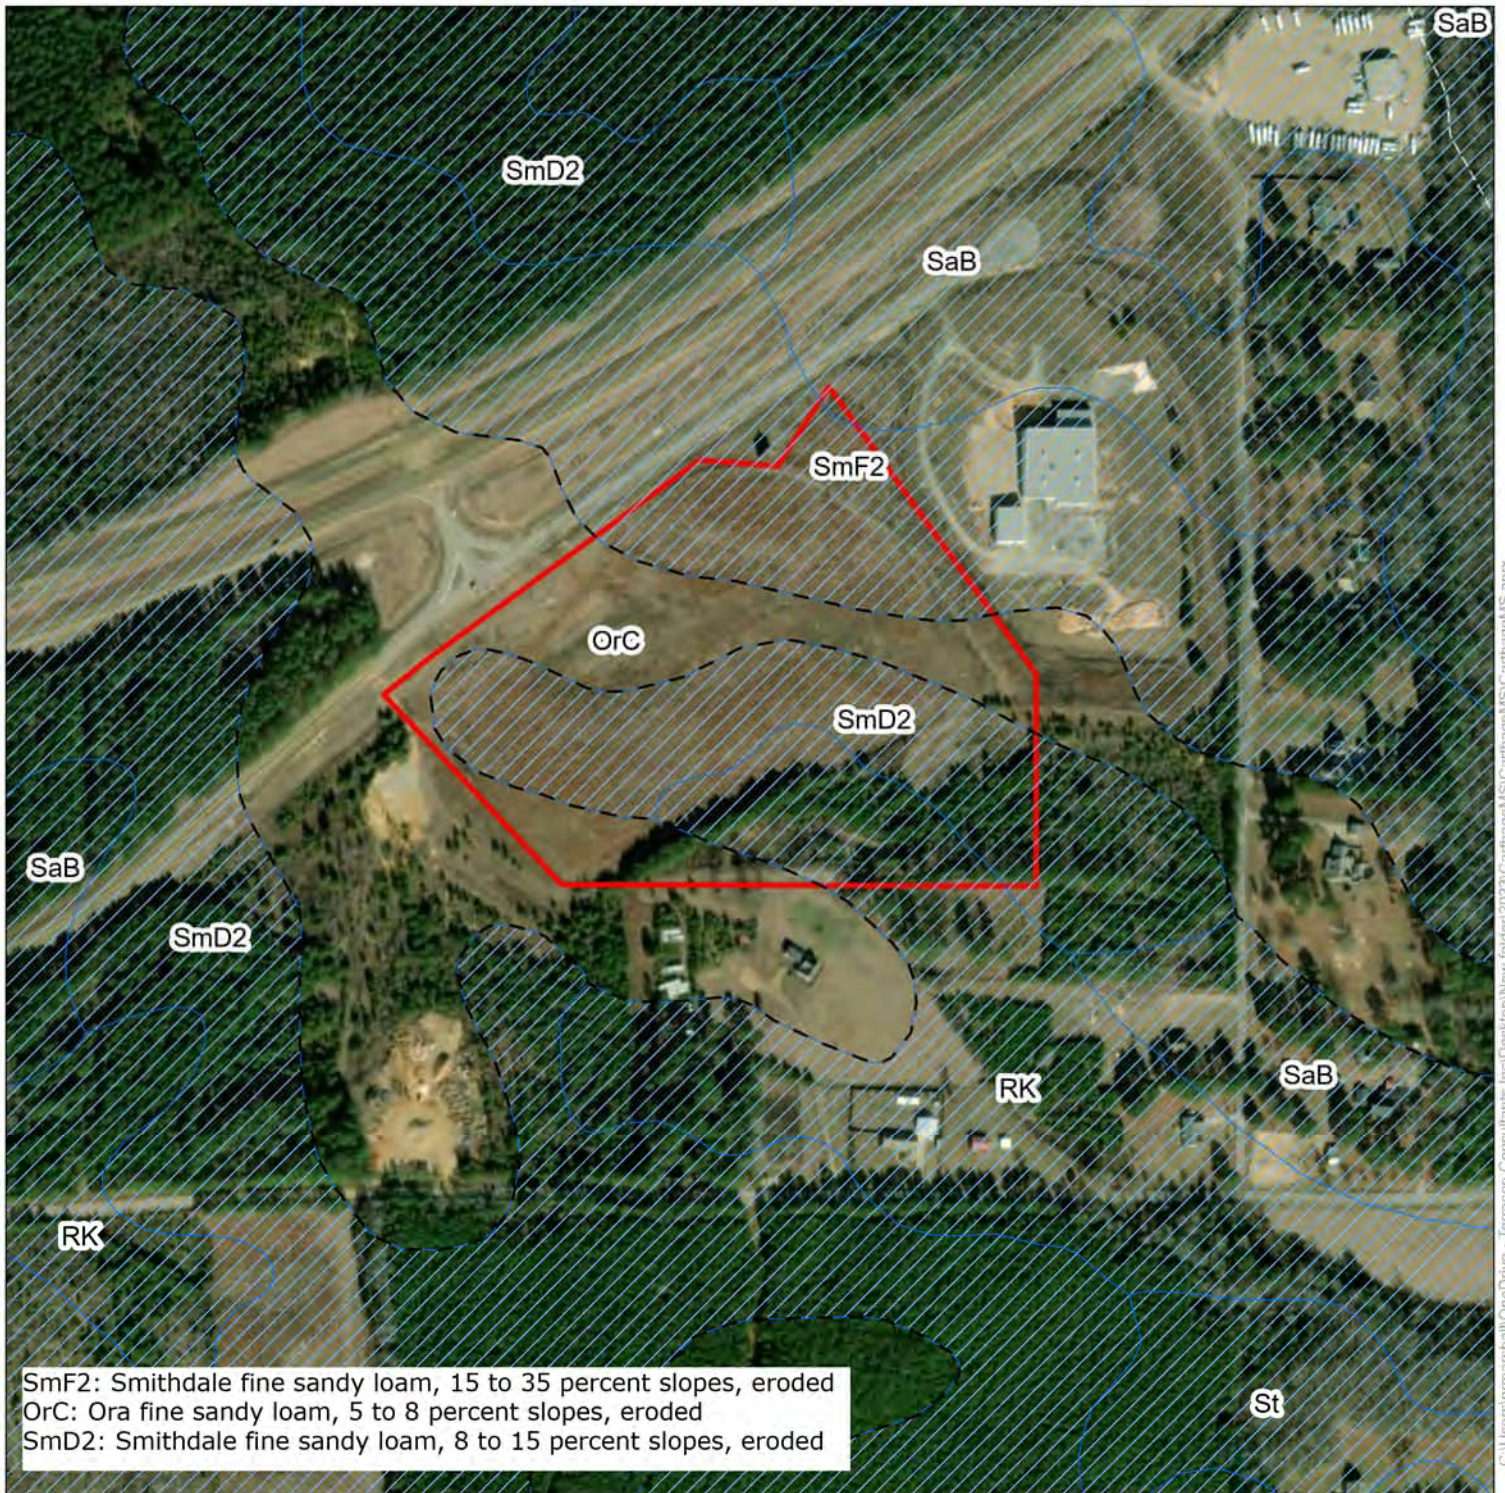
Based on a review of the NRCS soil data, a large portion of the site is made up of non-hydric soils except for an area on the southern portion of the site (Rk), see Appendix A Exhibit 4. The Rosebloom and Arkabutla soils (Rk) contains 100% hydric soils, and these soils make up approximately 13.9% of the site. These soils are in the southern portion of the site and are listed as frequently flooded.

USDA Soil Survey Map

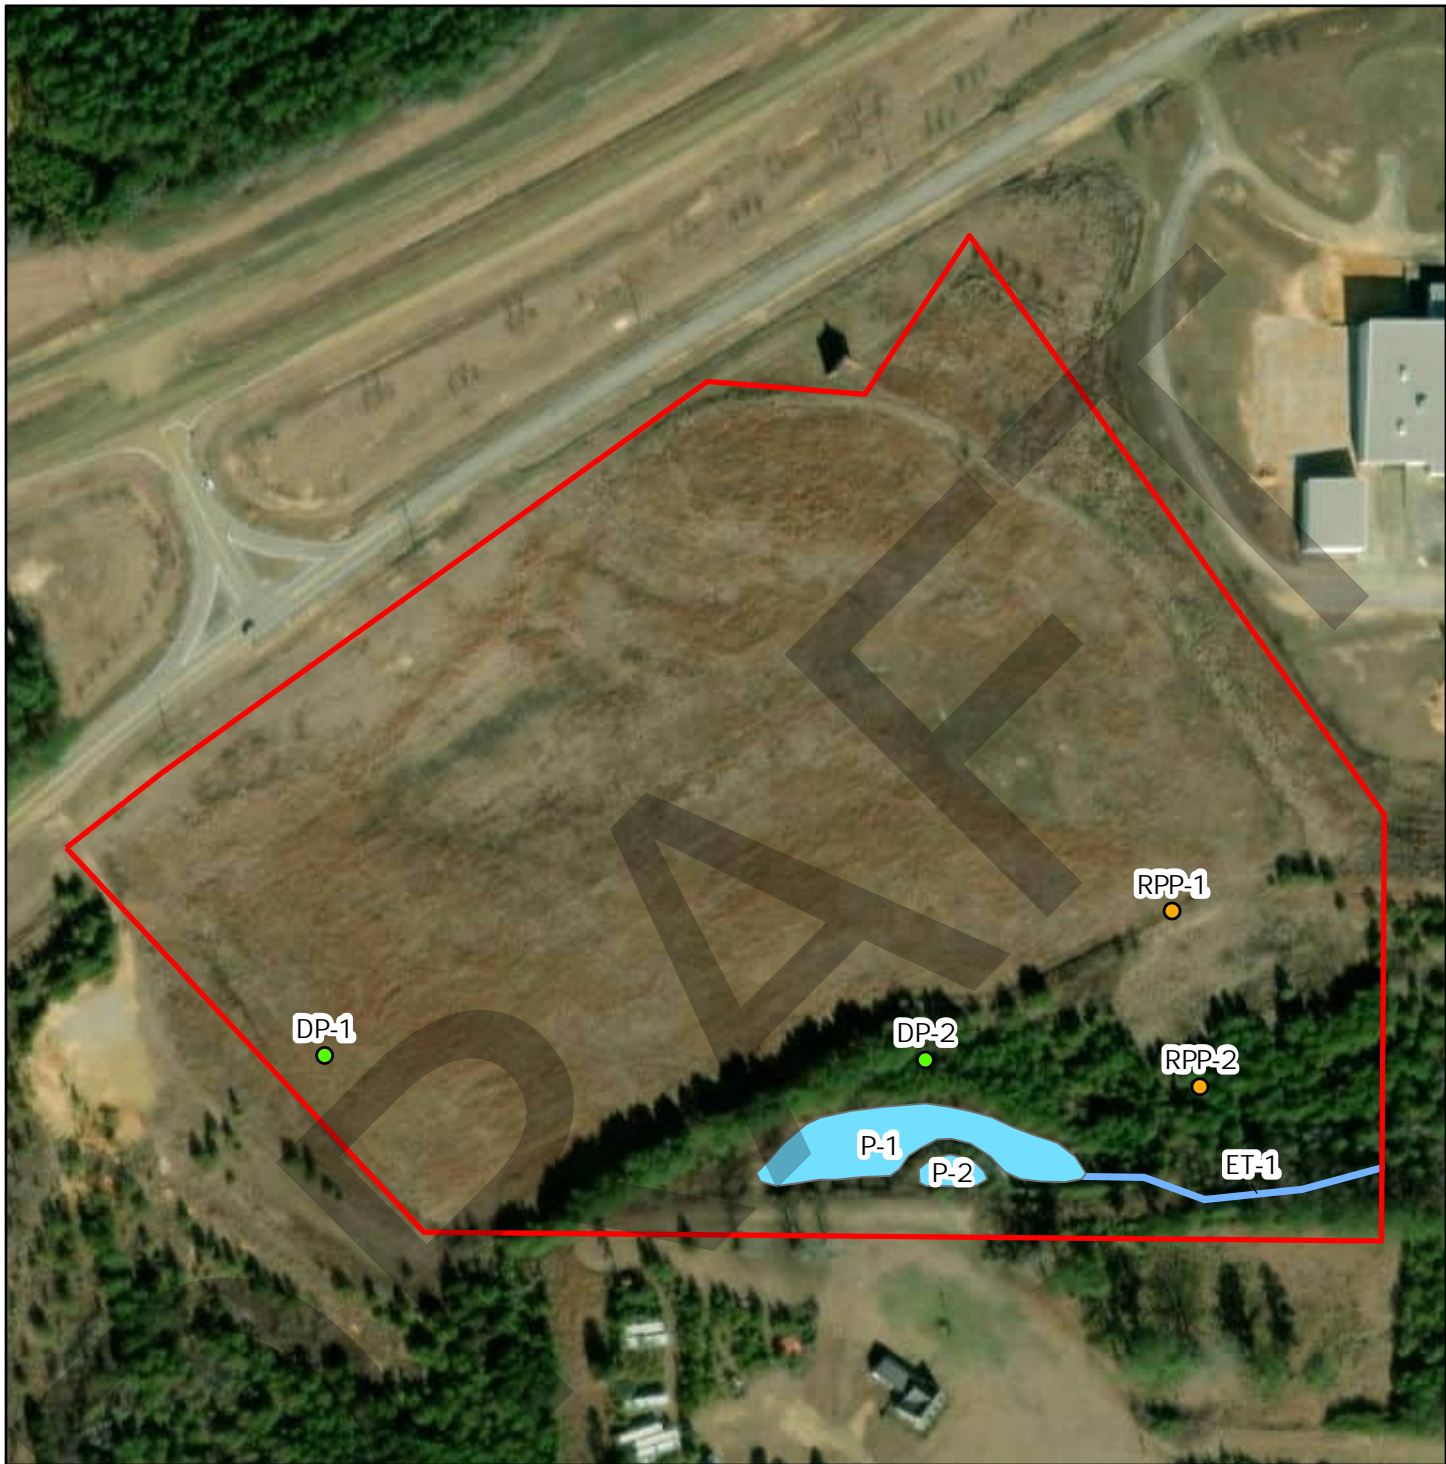
Exhibit
7.0

Terracon observed no potentially jurisdictional tributaries on the site. One ephemeral channel totaling approximately 320 Linear Feet (LF) was identified on the site. This channel was observed on the southern portion of the site. No tributaries were observed in the northern portion of the site. This ephemeral channel was observed to be approximately 4 feet wide and approximately one foot deep or less and were found to have a non-continuous ordinary high-water mark, therefore making these channels not an intermittent stream. Photo reference points were taken in these locations to document current site conditions (see Appendix C) and a map marking the locations these photos were taken are included in Appendix A, Exhibit 7. Table 3 contains a summary of the tributaries identified on site during the Field Delineation.

Terracon observed two small ponds totaling approximately 0.42 acres near the southern boundary of the site. Because of the recent lack of rain, the ponds were not holding water, but it was obvious that they typically do hold water. The ponds had no vegetation in them at the time of this study. Because the pond features are only fed by the ephemeral tributary, they are likely not jurisdictional. Table 4 contains a summary of other aquatic features observed on the site during Field Delineation.

Delineation Map
MS Department of Environmental Quality Leake County EDD Site 2 NE Leake County, MS Center 89.528°W 32.7715°N

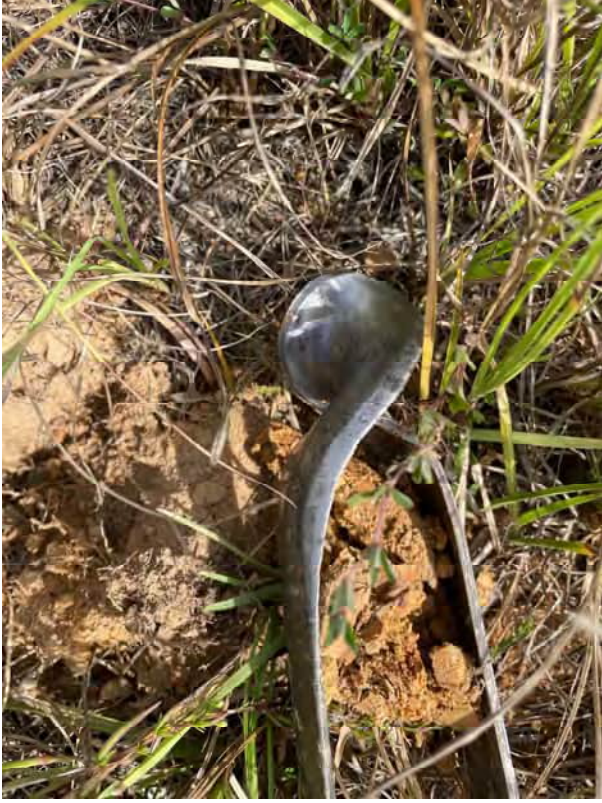
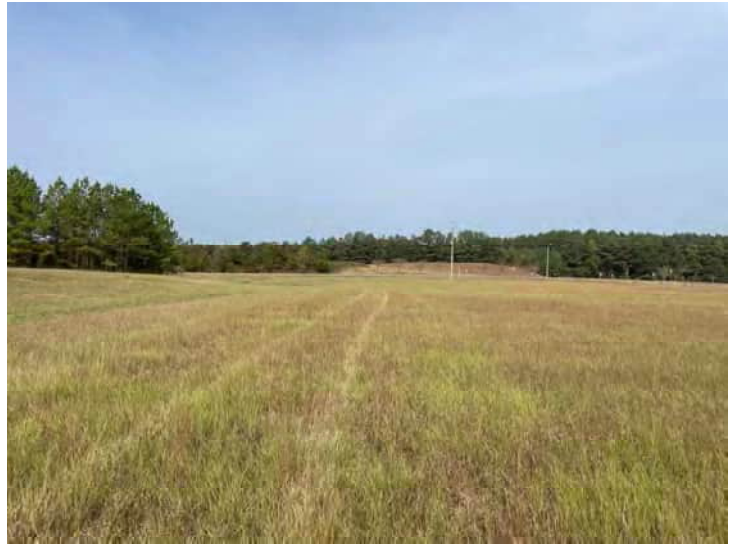
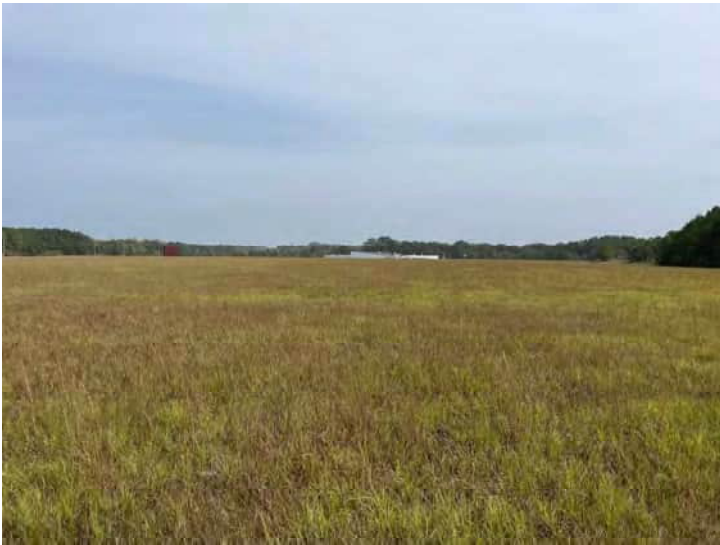
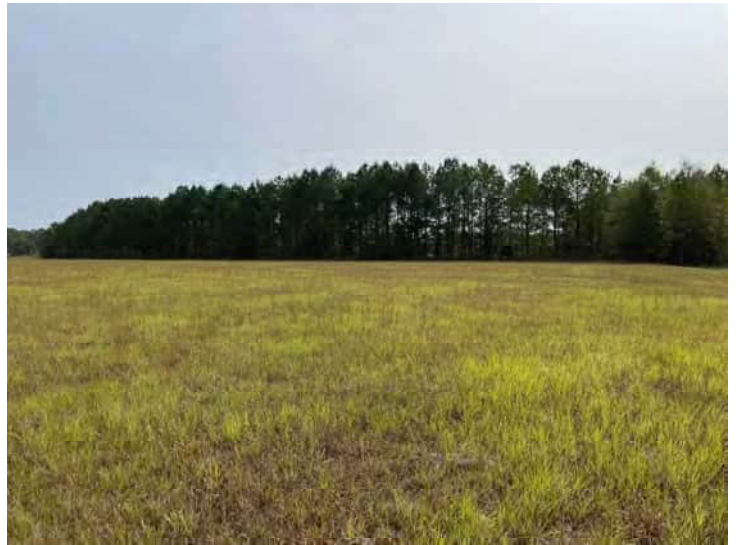
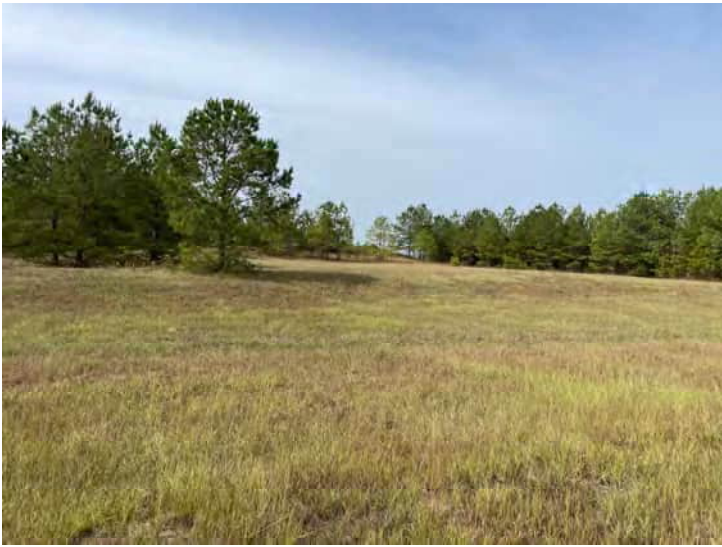
Depth (inches)	Matrix		Redox Features				Texture	Remarks
	Color (moist)	%	Color (moist)	%	Type ¹	Loc ²		
0-18	10YR 4/6	70	10YR 6/4	30			Silt Loam

Hydric Soil Present? Yes _____ No X

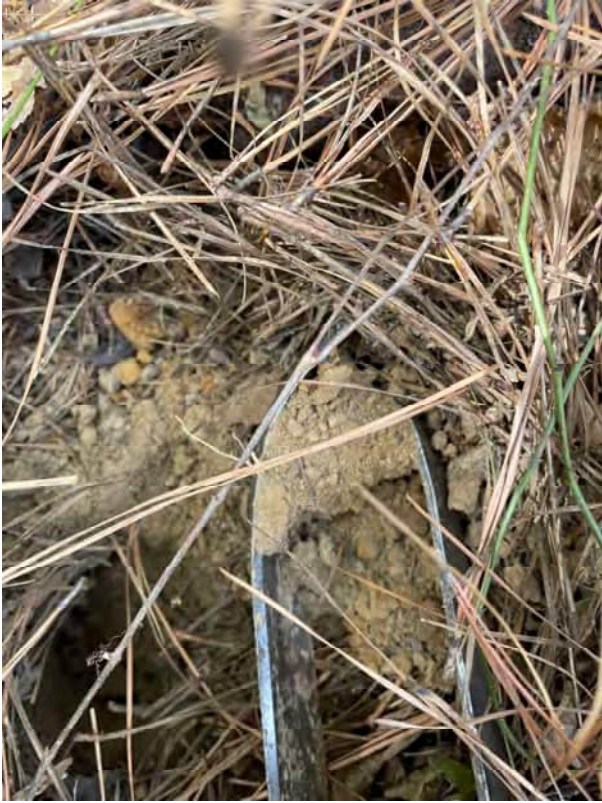
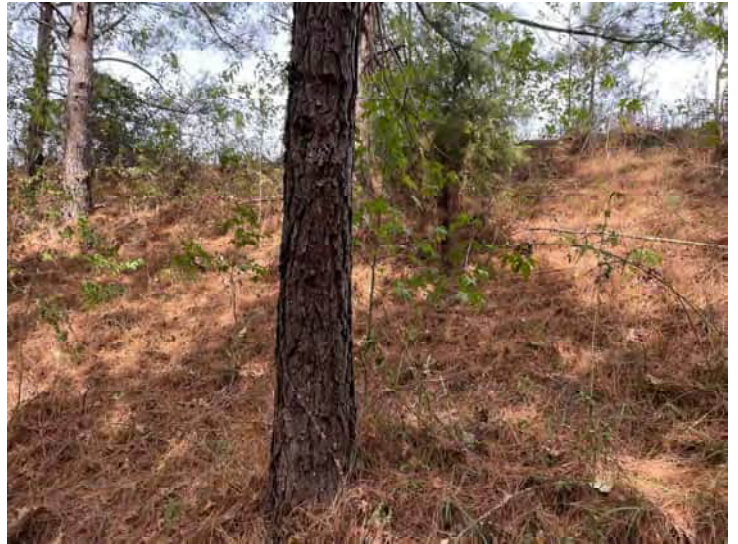
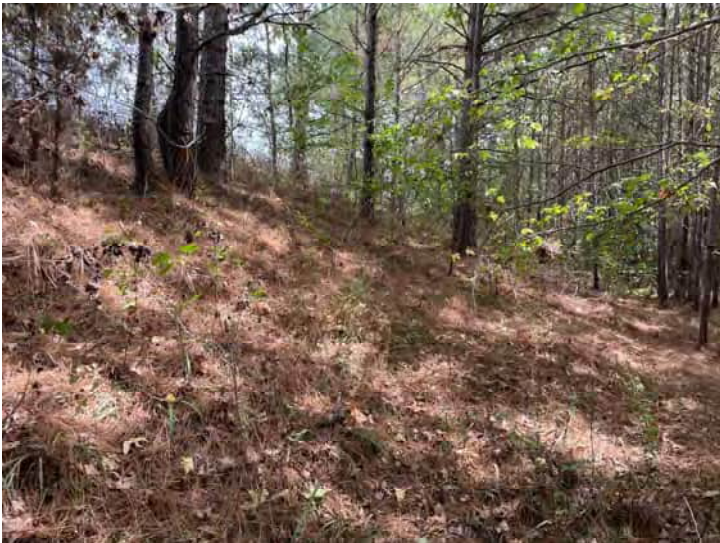
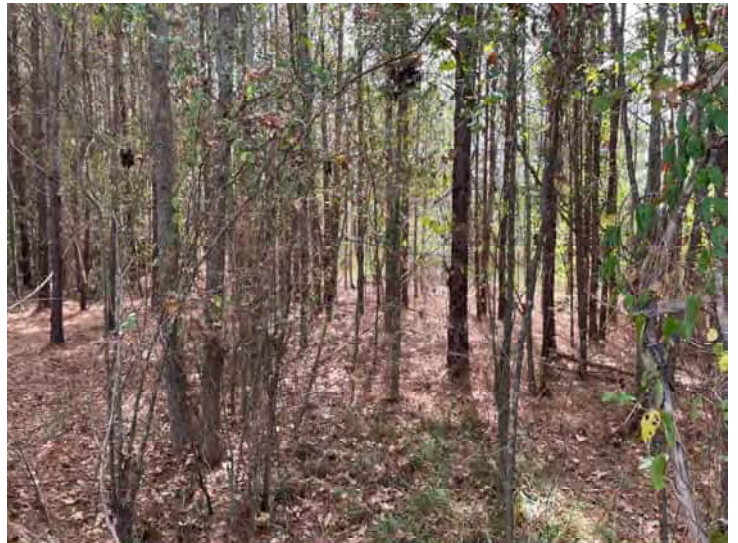
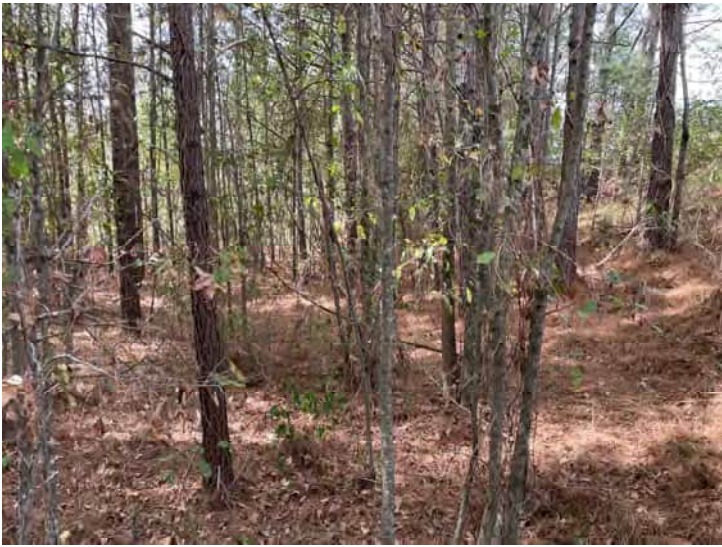
Sampling Point: DP 2

Depth (inches)	Matrix		Redox Features				Texture	Remarks
	Color (moist)	%	Color (moist)	%	Type ¹	Loc ²		
0-18	10YR 5/6	100

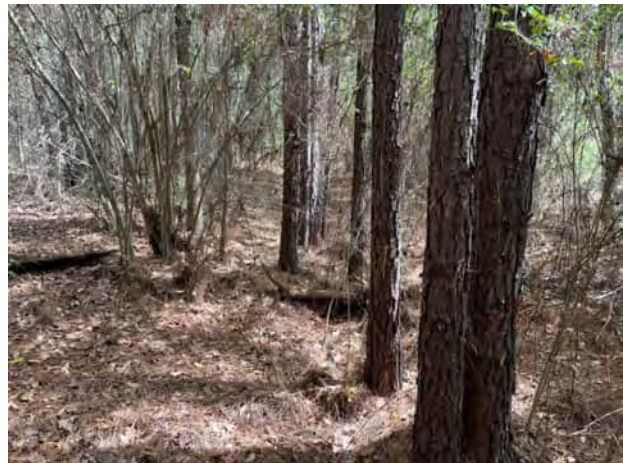
Ephemeral Tributary Photo
